BAYLY POND DAM

NDI ID NO. PA-00343

PHASE I INSPECTION REPORT
NATIONAL DAM INSPECTION PROGRAM

JULY 1981

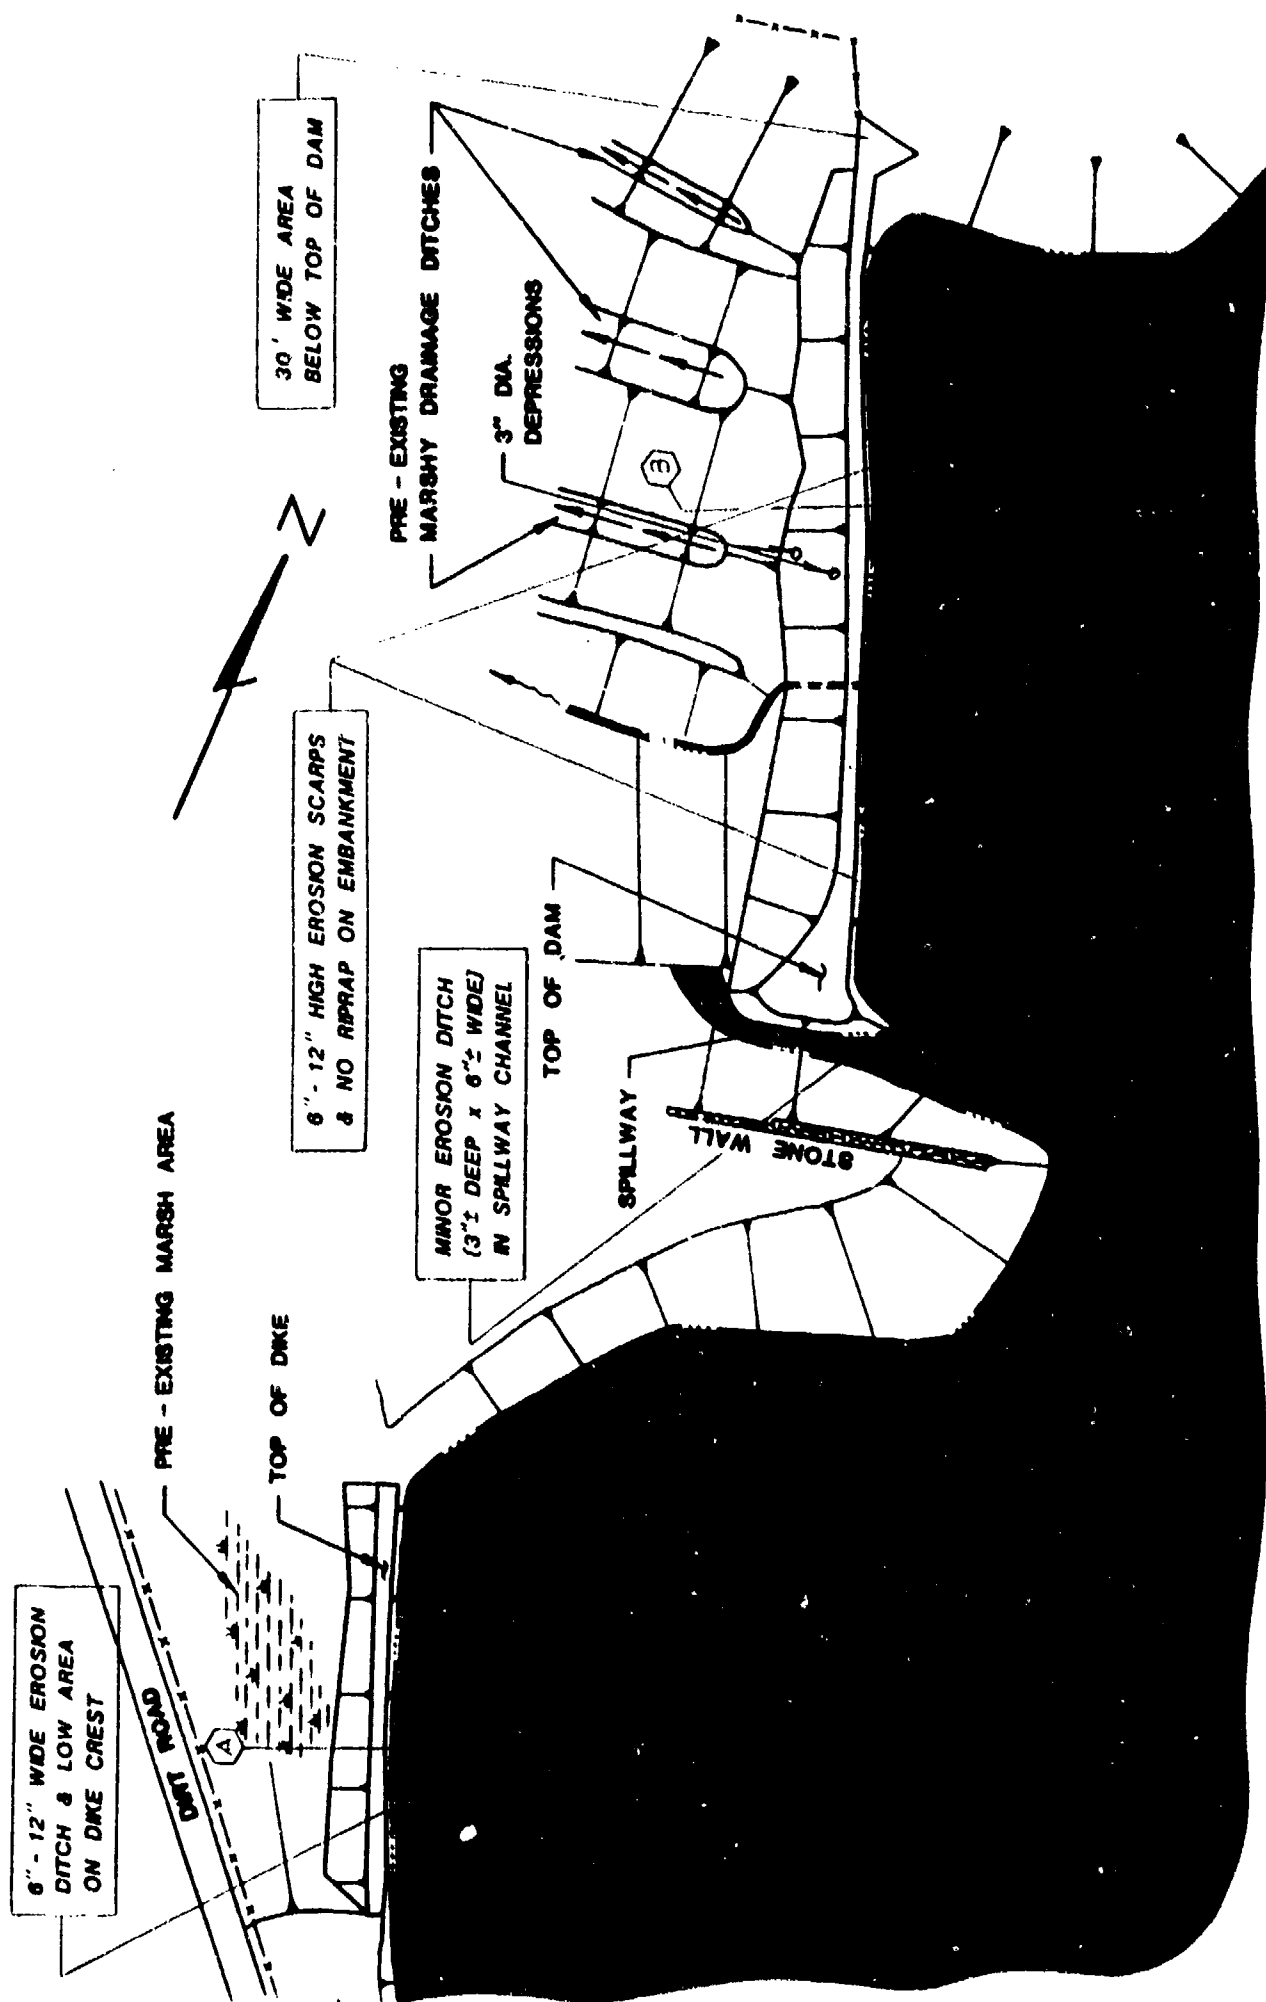
BAYLY POND DAM **GENERAL PLAN - FIELD INSPECTION NOTES**

b. Embankments: The earth embankments of the dam and dike appear generally sound. The upper 3' of the embankment on the pond side has been eroded by wave action. Softening of the embankment by cattle coming to drink water has aggravated this situation. No seepage areas were observed at the toe of the slopes or at the junction of the abutment and embankment. Marshy areas exist below the toe of both the dam and dike. According to the dam owner, the marshy areas existed prior to the dam's construction. Four shallow drainage ditches have been dug to drain the marshy area. Two 3-foot diameter shallow surface depressions are located on the downstream face of the dam, 70 feet right of the outlet pipe. Although there was no evidence of internal erosion or "piping" downstream of these depressions, they should be monitored (see paragraphs 6.1a and 7.2b). A 5-foot length of the dike crest near the center of the embankment has been backfilled with stone and earth, indicating overtopping erosion in this area.

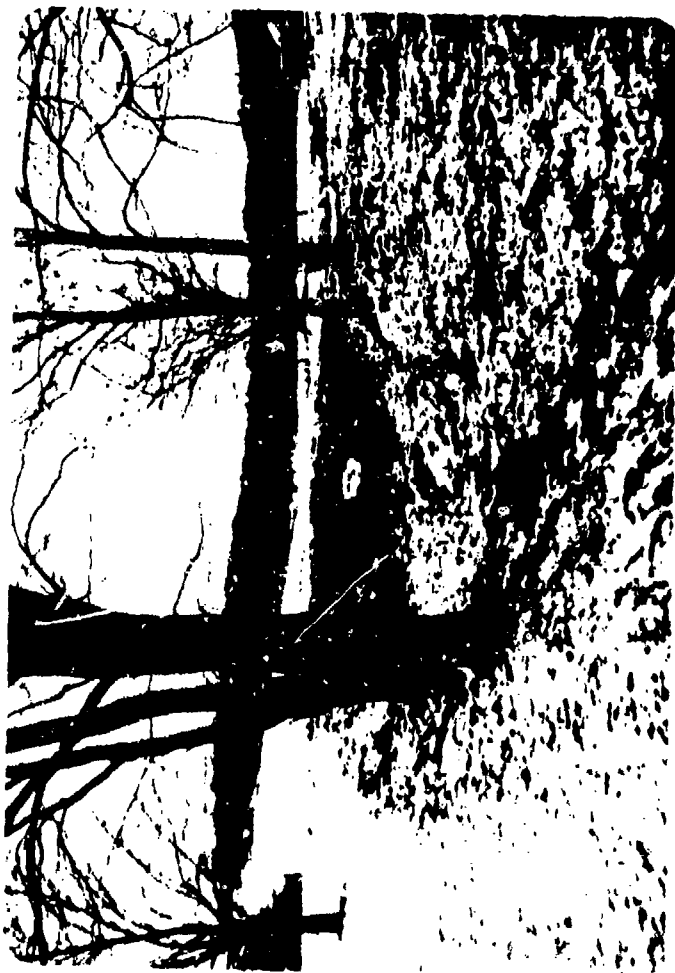
6. UPSTREAM VIEW OF ROAD CULVERT BELOW DAM
